## LIFELINE INSPECTION SERVICES

### RESIDENTIAL PROPERTY INSPECTION

2526 S Main St  
Molena, GA 30258

City Of Molena  
08/20/2026

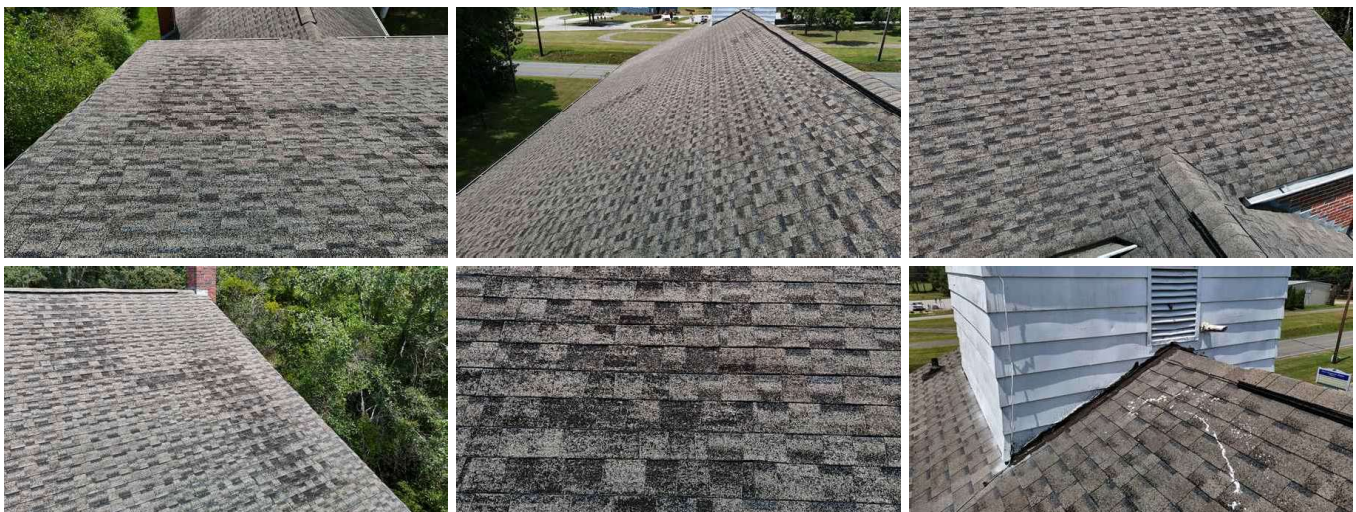
- heavy granule loss
- brittleness
- delamination
- areas of damage or missing shingles
- several areas of sealant applied in a presumed attempt to prevent leaks.

No active leaks were observed at the time of inspection but issues should be expected due to its age and condition. Replacement of the roof covering is recommended to be performed by a qualified roofing contractor.

Contact a qualified roofing professional.

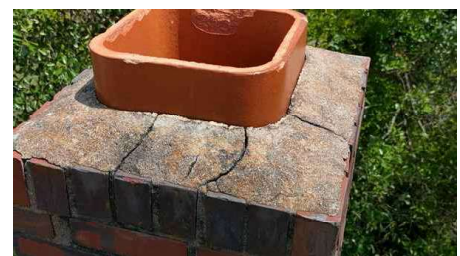
## 3.6.1 Chimney

**CROWN - CRACKING**

The chimney crown had some degree of cracking present. This can allow for rainwater infiltration into the masonry, and in freezing temperatures this infiltrated rainwater can freeze and expand allowing for damage to the masonry. Evaluation and repairs or replacement of the crown as needed is recommended to be conducted by a chimney sweep or other qualified person.

Contact a qualified chimney contractor.

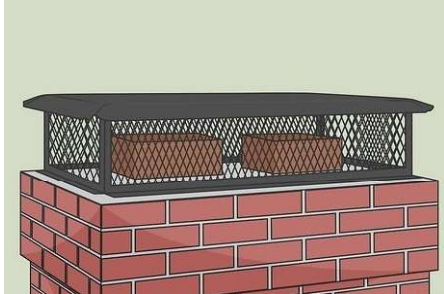
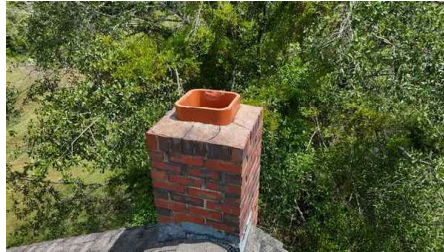
## 3.6.2 Chimney

**FLUE LINER(S) - RAIN CAP MISSING**

Flue liner(s) were present that were not protected by a rain cap. Rain caps are recommended to protect the flue from rainwater that may cause cracks while the chimney is in use, and to prevent the entrance of wildlife and moisture into the chimney. The installation of chimney raincap(s) is recommended to be performed by a qualified person.

Contact a qualified chimney contractor.

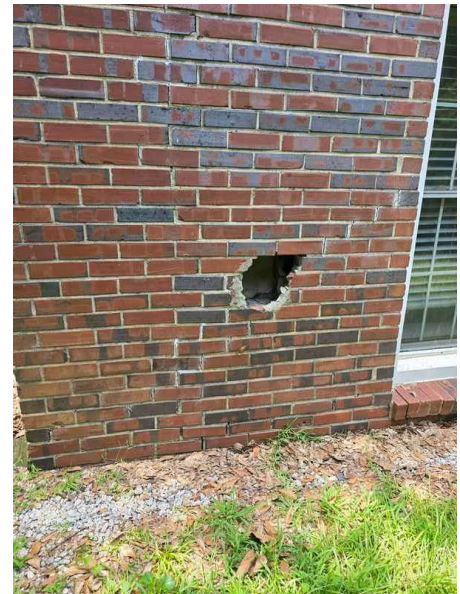
### BRICK - DAMAGE

Damaged brick(s) were present at the rear of the building and left an opening for pest or moisture intrusion. Repairs to the damage is recommended to be conducted as needed by a qualified mason.

Contact a qualified masonry professional.

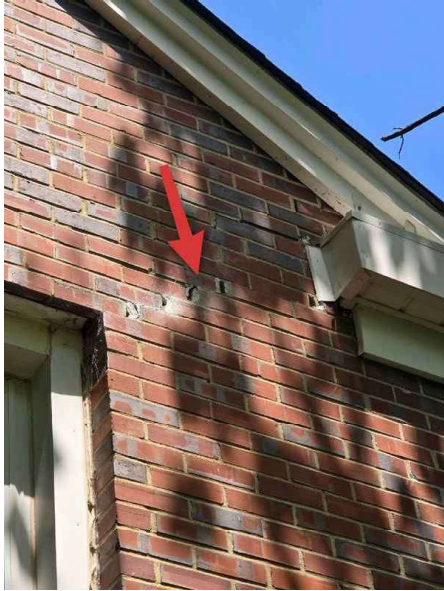
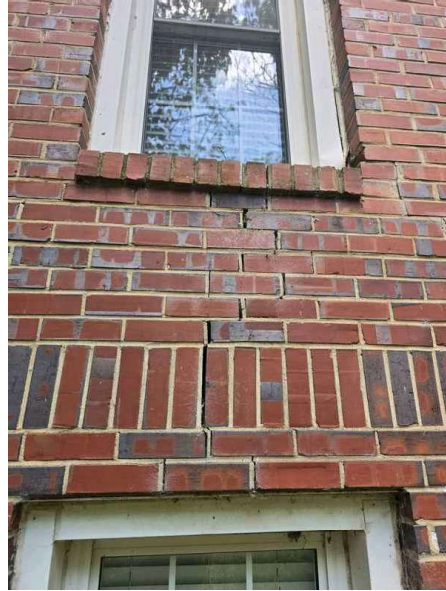
## 4.3.2 Brick

The brick veneer was cracked in several areas. One area at the back right has pulled away from the structure putting it out of plumb. Evaluation by a qualified mason is recommended with repairs made as needed.

Contact a qualified masonry professional.

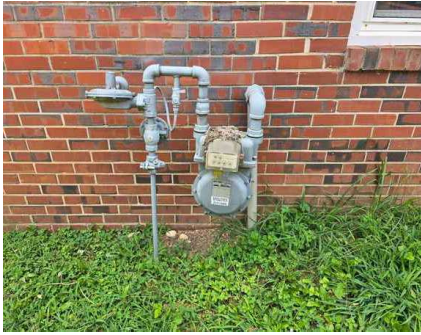
**FYI** - The gas meter was locked in the off position at the time of inspection. Any items depending on gas for operation are excluded from this inspection.

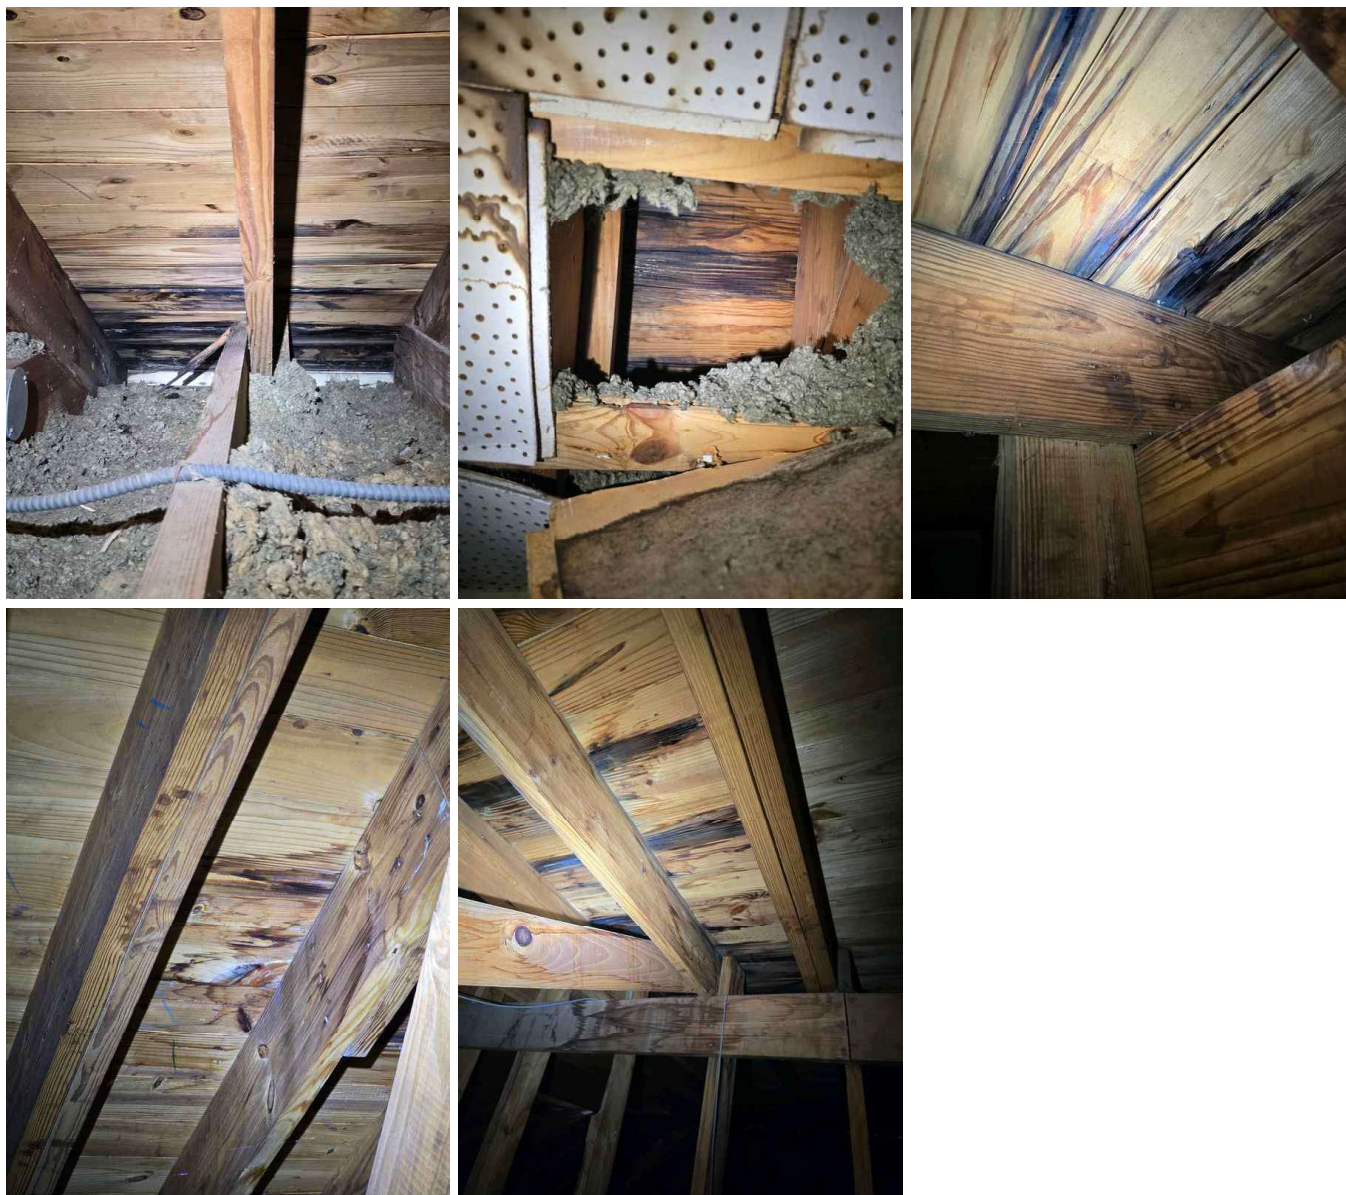
## 6.5.1 Roof Structure / Framing

6.5.1 Attic, Roof Structure, & Ventilation - Roof Structure / Framing: Roof Structure - Moisture Damage Present

Contact a qualified roofing professional.

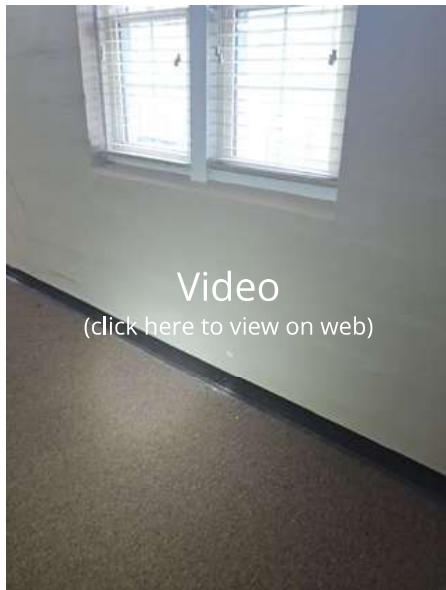
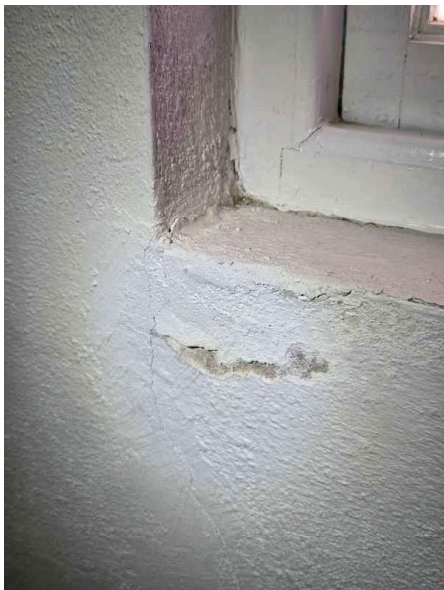
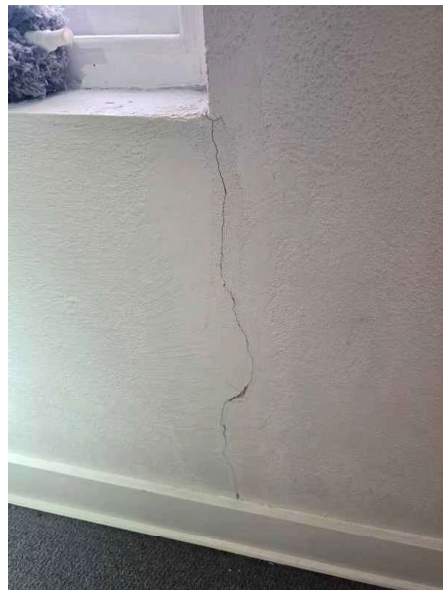
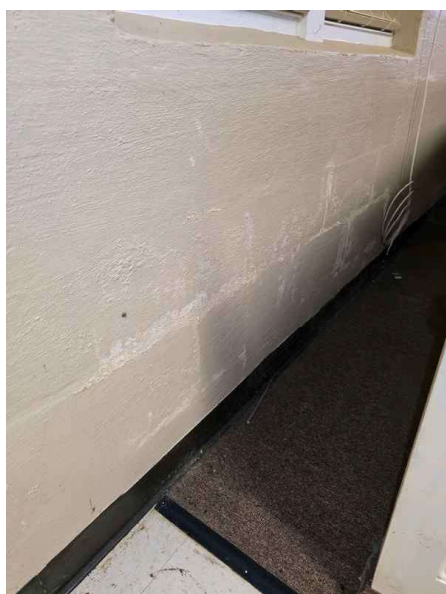
11.2.1 Basement Foundation Area - Moisture Presence: Moisture - Indications of Past/Present Moisture (Finished Areas)
  -

Contact a qualified waterproofing contractor

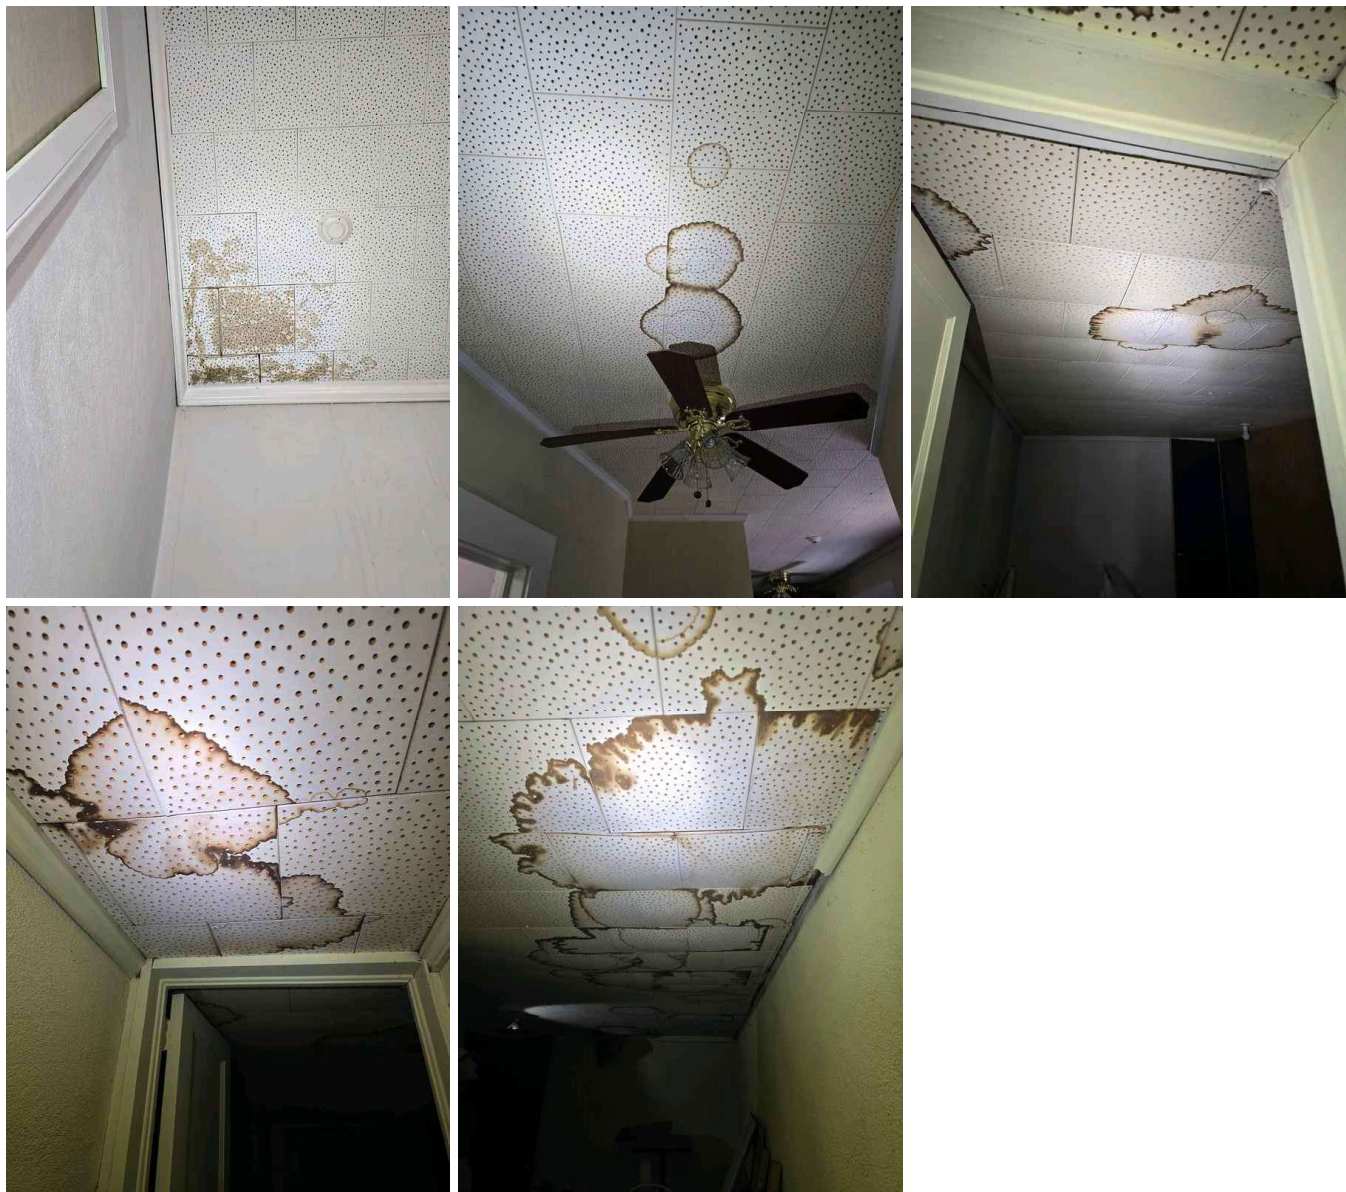
12.3.1 Interior - Ceilings: Moisture Staining - Roof

Contact a qualified roofing professional.

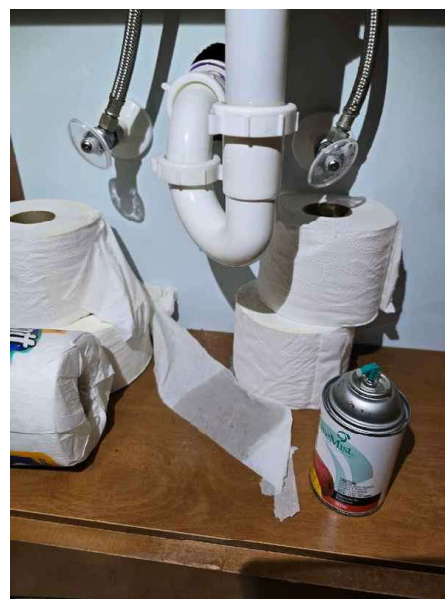
Upstairs Bathroom

13.6.1 Bathroom(s) - Undersink Plumbing: Leak Present
  -

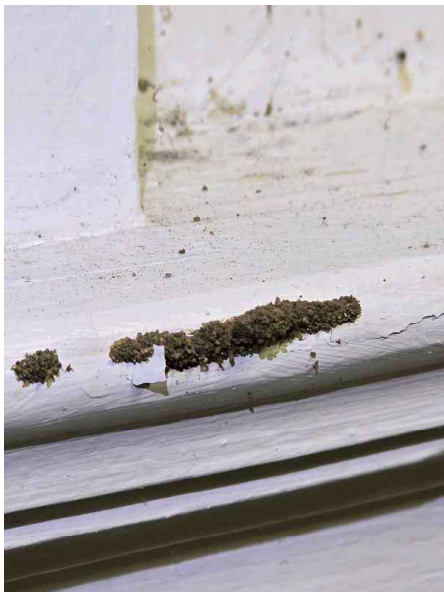
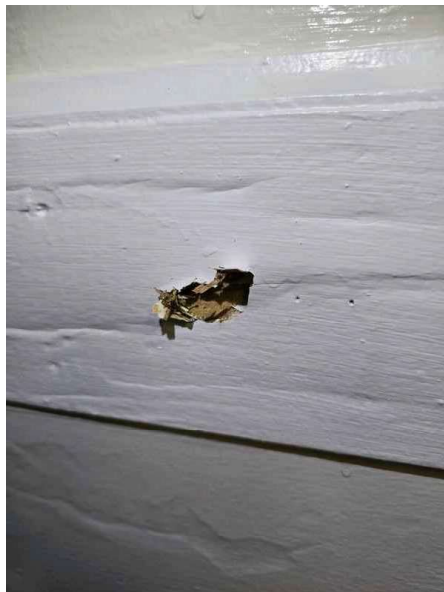
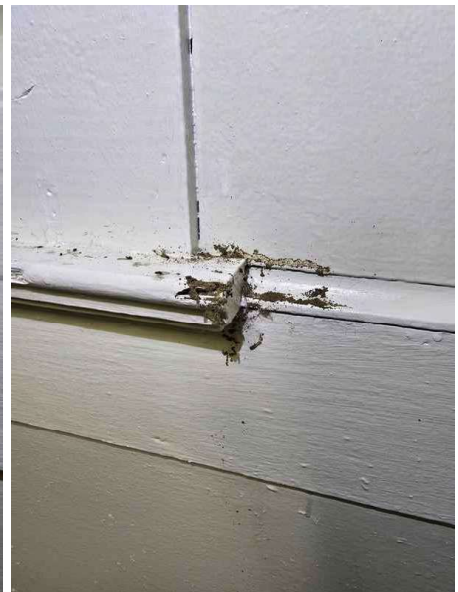
## 15.6.1 Pest/Insect/Wildlife Concerns

15.6.1 Environmental Concerns - Pest/Insect/Wildlife Concerns: Presumed WDI - Damage Present

Contact a qualified pest control specialist.
